Report on retrofitting a COMPACT exhaust air purification system

Construction project: THE MADISON Hotel Hamburg / kitchen

Client: GTH - Gebäude Technik HH GmbH & Co.KG

Dates of documentation: 16 January 2020 and 10 March 2020

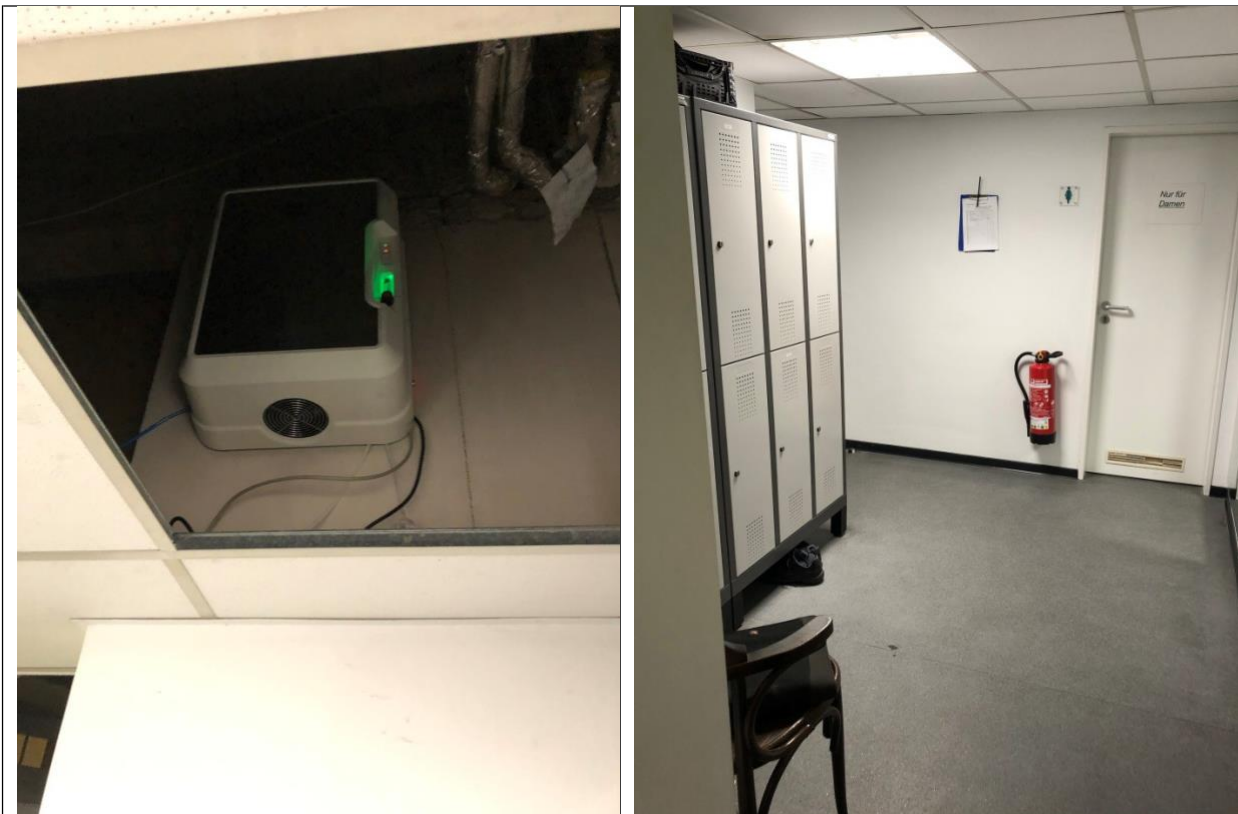
Pictures of the installation

Installation: The exhaust air purification unit is installed in the basement in the false ceiling of the changing room. The kitchen is located on the ground floor. The Teflon hose has a length of approx. 25m (including branch for two ventilation hoods). The injection spears are installed in the ventilation system about 3m above the cooker hood. An ozone sensor is placed at the COMPACT unit and one differential pressure switch each in the exhaust air duct directly at the ventilation hood.

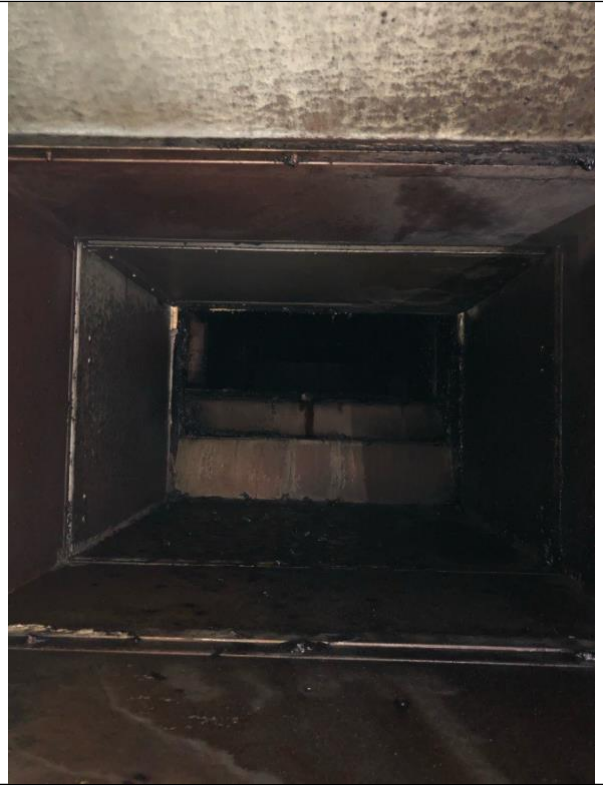
Filter change/duct inspection 16.01.2020

This filter is completely black after about four weeks (maintenance interval) and the ducts are also heavily clogged.

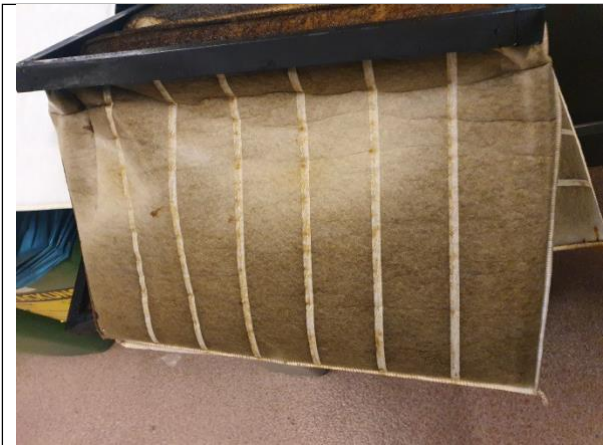
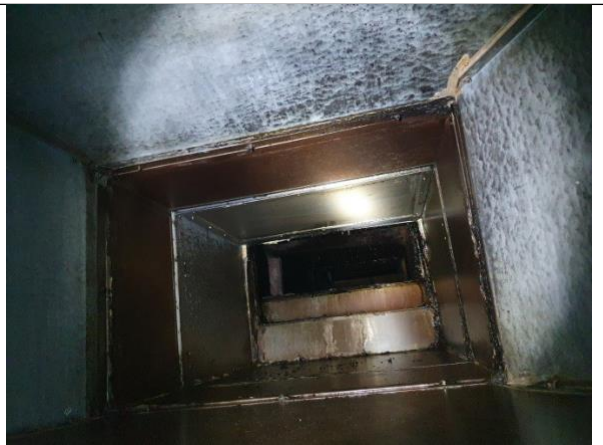
Filter change/duct inspection 03.03.2020

Result: The grease load in the exhaust air was significantly reduced by installing the COMPACT ozone generator. The filter is no longer black with grease, but merely brownish. The inner wall of the duct is cleaner than at the previous maintenance interval.

Note: Existing, older grease deposits cannot be dissolved by the unit, as they have already hardened. However, improvements (smoother surfaces) may occur.

The COMPACT unit has been provided for test purposes. At the end of the test (approx. two months) the device remains installed on site. Mr. Rusche (Technical Department, THE MADISON) is very satisfied with the result and the improvements. Maintenance will now be carried out in longer intervals. The existing UV tubes in the hood will be removed. Mr. Kleinertz (Director THE MADISON) has given his approval for operating with the COMPACT instead of UV tubes.
